FOREST PRODUCTS RESEARCH IN PICTURES

NO. 53

**ACRES OF WHITE PINE TIMBERS
LAID LOW BY DECAY**

**FOREST PRODUCTS LABORATORY
U. S. FOREST SERVICE
MADISON, WISCONSIN**

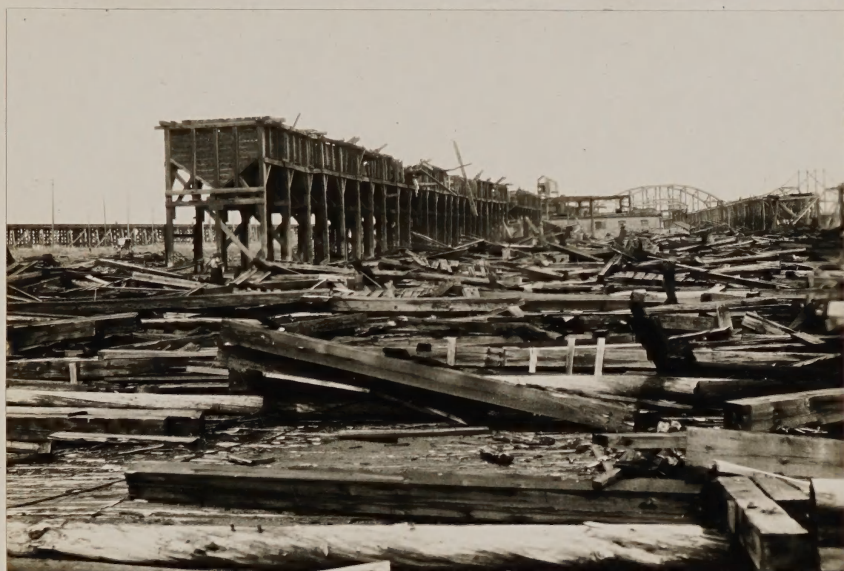
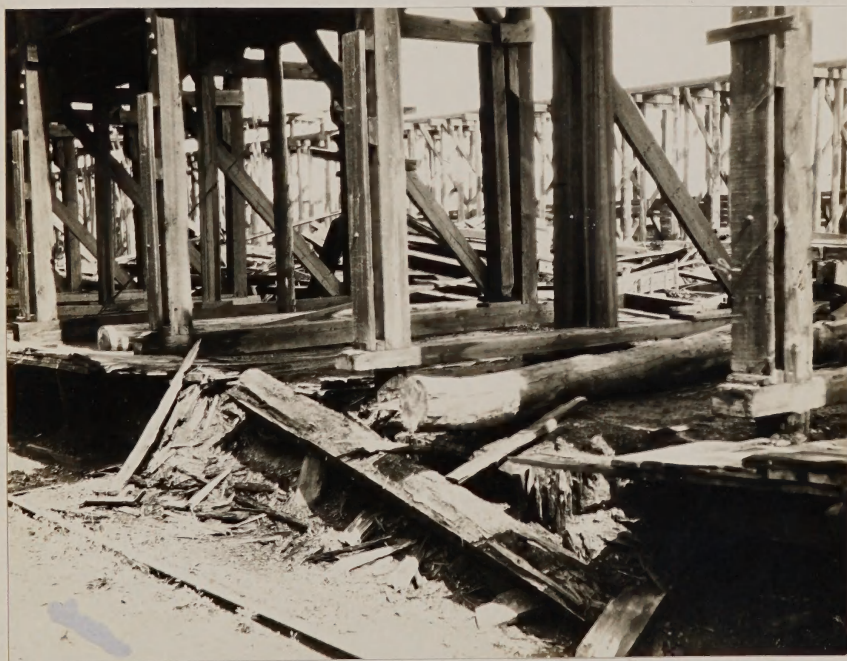
Decay was the agency responsible for the condemning and wrecking of the railway coal terminal shown here. A large part of the white pine timber is still sound but the joints are badly rotted. This is one of many illustrations of the fact that a wooden structure is generally serviceable only so long as the joints are sound. In the case of treated timbers much of the effort and expense of treating is wasted if the untreated wood is cut into at the ends in installation and not subsequently protected with preservative. When practicable the best method is to cut the timber to length, "frame" it completely and then give it a thorough preservative treatment.

By making extensive repairs from time to time this structure was made to give long life without treatment. The repairs could have been avoided and longer life obtained if the timber had been thoroughly treated. It was apparently not considered economical to treat these timbers when the structure was built, although good preservatives were obtainable. Conservation expedients do the most good when they are adopted before dire necessity dictates their use.
